Aviation Safety

Maintainer

Issue 3/2000

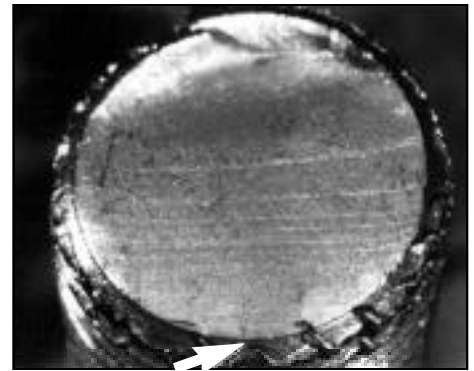
- * The No. 3 cylinder lower forward through-bolt was missing its nut.
- * The $\frac{3}{8}$ -in. studs and the $\frac{1}{2}$ -in. through-bolts of the No. 2 cylinder failed from fatigue.
- * It is probable that insufficient torque was applied to the No. 2 cylinder nuts at some time.
- * Based on the material analysis results and the observation of fatigue propagation on the fasteners, it can be concluded that the probable

Fracture surface from one of the $\frac{3}{8}$ -in. hold-down studs from the No. 3 cylinder. Beach marks are clearly visible. Arrow points to the origin area.

cause for the fatigue failure of the hold-down studs and through-bolts was that the torque applied to one or more of the nuts was lower than specified. This reduced the pre-load tension in the stud to the extent that the tensile component of the cyclic stress on the fastener could cause a crack to form. The crack progressed in fatigue until a failure occurred and, once a single stud failed, the loading on the others would increase to cause the remaining bolts to fail in a very short time.

The fact that the No. 3 cylinder, which is on the opposite side of the engine (but not opposite to No. 2 cylinder), failed in a similar manner earlier suggests that even though the AME had retorqued all the cylinders as claimed at the time the No. 3 cylinder was replaced, possibly this engine was a failure waiting to happen. There is a strong possibility that it had been in service for a long period of time with improperly torqued cylinder hold-down bolts on one or more cylinders and, as the findings suggest, the only known quantity is that the failure initiated at some point in time then progressed to catastrophic.

Although all the applicable bolts and studs were replaced at the time of the No. 3 cylinder change, it is also a good safety precaution to conduct non-destructive testing (NDT) of the studs and bolts whenever a cylinder base nut is found with a loss of specified torque.—Ed.

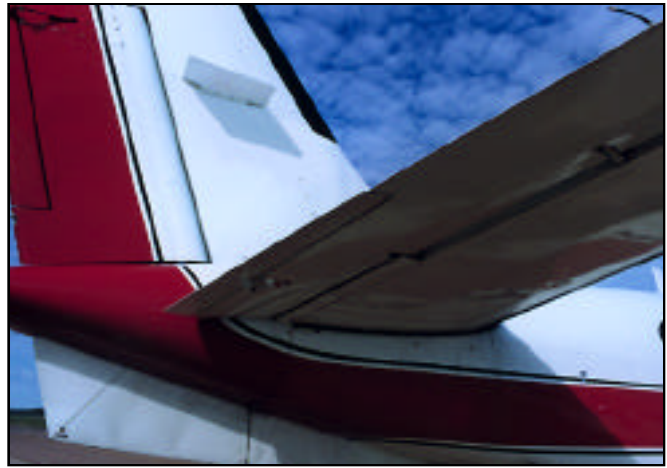
Maintenance determined that the hardware connecting the rudder trim actuator push/pull rod to the rudder trim tab horn was missing. The *Beechcraft 90, A90, and B90 Series Illustrated Parts Catalogue* (IPC Fig 54, page 3, Index # 42) specifies that the attachment hardware used to connect the rudder trim actuator include an AN173 bolt (no length specified), two AN320-3 castellated nuts and two AN380-2-2 cotter pins.

The bolt and associated hardware securing the push/pull actuating rod to the rudder trim tab horn was missing after the occurrence. There are several possibilities as to why the bolt failed to remain secure: it was not there on takeoff, it fell out at some point, or it broke during flight. The first hypothesis is not likely because maintenance would have noticed this during pre-flight inspections or the flight crew would have experienced the problem immediately after takeoff. According to the report, in order for the bolt to fall out during flight the cotter pin was either missing or it broke during the flight, allowing the nut to back off and the bolt to move upwards against gravity. The cotter pin was present during the previous free play check and, as there is no force on the pin, it is unlikely that it would subsequently break. Installations of this assembly were inspected on the operator's other King Air aircraft, and it was noted that the bolt threads were painted. This would decrease the likelihood of the nut backing off even if the cotter pin were missing. Furthermore, the bolt is held in place by a bushing in the trim tab horn. The fit between the bushing and the bolt is quite tight. This ensures that the rudder trim will pass the free play check, which demands a tolerance of only 0.021 in.

The third hypothesis, that the bolt broke in flight, is the most likely scenario. The fracture would not have been due to overload stresses because there was no evidence of deformation on the clevis or trim tab horn. However, if there were cyclic loads of sufficient magnitude present, the bolt could have failed in fatigue without damaging the surrounding components.

As the shank of the AN173-5 bolt does not extend all the way through the lower arm of the clevis, a fatigue crack could have developed at the threads because of a stress concentration as a result of the shear load. The shank of the bolt, however, is thicker than the threads and therefore prevents them from coming in contact with the clevis and bearing any load.

The bolt may have been manufactured from sub-standard material or may not have been an aircraft quality part. As the bolt was not recovered, it was not possible to examine it. Several samples of attaching

1. Transport Canada has written the FAA recommending that Raytheon Beech be contacted to have the aircraft maintenance manual amended to include complete assembly instructions and illustrations.
2. Transport Canada does not recognize the illustrated parts catalogue as an authoritative document for the purposes of assembly, only for the identification of appropriate parts.
3. The operator has verified that all parts in their parts supply section conform to the required specifications and are in the appropriate bins. In addition, the operator provided training for all warehouse and procurement staff and AMEs on bogus parts to increase their awareness on this issue.
4. The operator amended the maintenance control manual to enhance parts control procedures. 📌

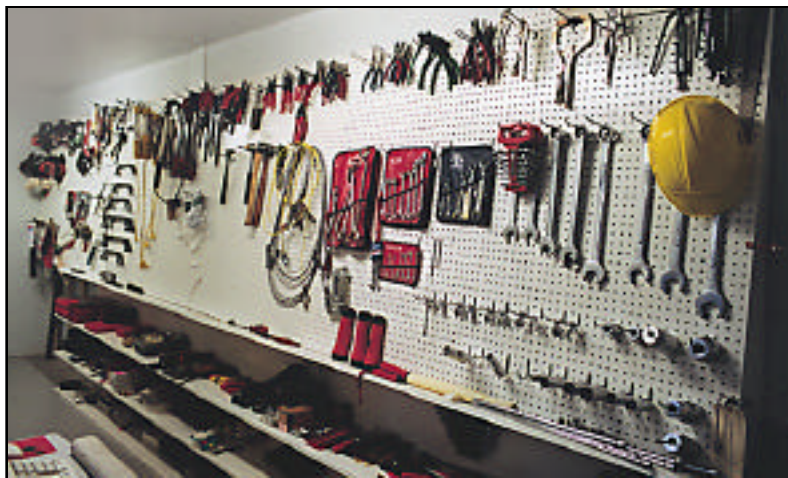
*The quality of repairs often depends on locating the correct tool. The board above, inclined slightly **out** at the top, is an excellent way to locate and track tools where multiple users are involved. A silhouette or number system on the board can be used to quickly verify that no tools have been left in the work area after each day's use.*

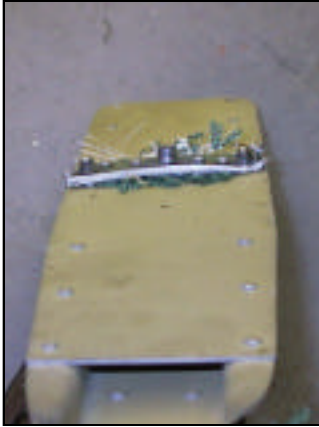
During the investigation of a recent Cessna 310 accident, a separate issue arose concerning re-upholstery work performed about two years previous. During the impact sequence, all occupied seats detached. The centre row of passenger seats not only detached from the seat rails, but the seat rails also broke free from the cabin floor.

Apparently, the installer did not cut away the carpet from where the seat rails attach to the cabin floor. Maintenance found $\frac{1}{2}$ in. carpet with $\frac{5}{8}$ in. foam underlay between the seat rails and the cabin floor. This oversight contributed to the seat rail's detachment from the airframe.

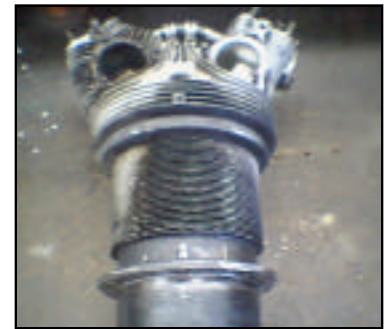
The engine problem was further investigated by the company maintenance and subsequently by a representative of the engine overhaul facility. Information provided indicated that a valve in one of the engine's cylinders had been sticking; the cylinder head to cylinder barrel joint was showing evidence of the initial phases of separation and a cylinder change was required.

Note the discoloration where the barrel joint and head join on this failed cylinder, which is similar to that of the affected aircraft.

been contacted to check the problem, which may have prevented further flight with a faulty engine. Second, AMEs need to be vigilant for the early signs of a failing cylinder and replace it. 🛠️

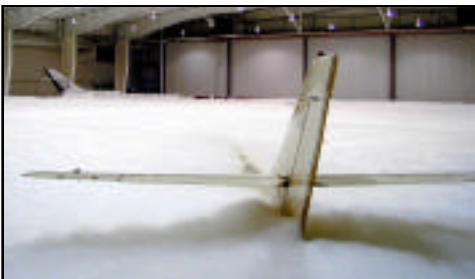
According to the story about this photo, a new aircraft wash facility had just been established. In keeping with the computer age, all you need to do to wash an aircraft in the new facility is push the aircraft into place, make the necessary settings on the equipment, shut the door and presto!—the aircraft is automatically washed.

On a serious note, apparently this aircraft was placed in a cleaning hangar for a wash job. The water hose, which was equipped with a foam nozzle and quantity of soap in the applicator, was accidentally left with the water running over the weekend and this was the Monday morning result. 🛠️

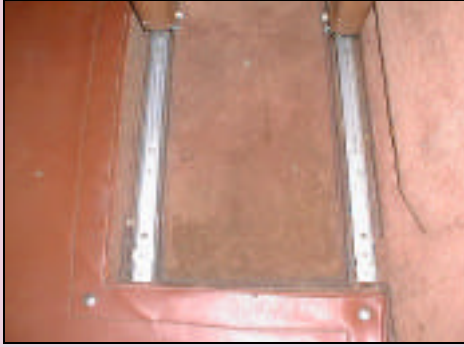
In a recent PA-31 accident, severe distortion and breakage of the seat retention rails resulted in the release of one of the seats from its secure mounting. The passenger in that seat was thrown around the cabin but, fortunately, was not seriously injured. Seat rails under two other seats were distorted, but those seats, along with their passengers, remained in place. Rail distortions coincided with

locations where at least one seat rail retention screw was missing. An examination of a number of other Piper PA-31 aircraft revealed that it is common for screws to be left out of the seat retention rails, probably as a result of changing the cabin between passenger and freight configurations. Seat extraction requires removal of the screw-retained seat stops. It is likely that the loose screws and seat stops are misplaced and are not installed when the seats are returned to the aircraft. Also, variation between model years occurs with respect to floor holes and nut plates, which could result in gaps of as much as 12 in. between screws. Where gaps exist, there is more likelihood of rail distortion and breakage in a sudden deceleration.

AMEs responsible for maintaining this aircraft type must review pertinent seat installation requirements after any configuration change and ensure that the rails are properly re-attached. There should be no missing screws where nut plates are installed in the floor to accept them. 🛠️
